**Flood Control Project Maintenance
Levee Inspections**

Fall 2019 Levee Maintenance Deficiency Summary Report

**Flood Control Project Maintenance
Levee Inspections****LMA District Cover Sheet****Fall 2019 Levee Inspection Results****Reclamation District No. 0341 Sherman Island**

Reclamation District No. 0341 Sherman Island

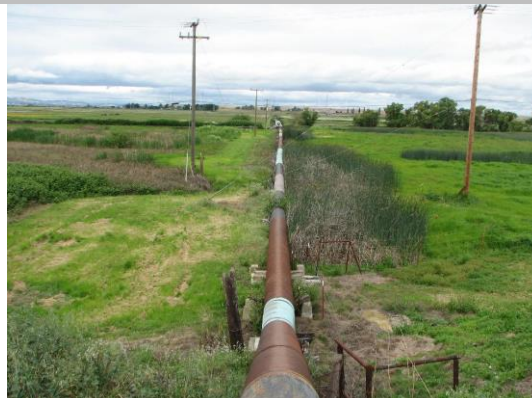
Photo 3 of 3 : UCIP_FA_2019_52252_37642.jpg

Comment Code						
Inspector Comment						
DS_ID:24215 FS_ID:52252 EP_NO: N/A Repair Type: Non-Urgent Crossing Status: Found UCIP Comments: 05/05/2009 Dense vegetation limits the inspector's visibility to identify signs of pipe failure (leaks) along the slopes. Recommend removing vegetation along pipe alignment to conduct proper inspection of structure and appurtenances. (DWR UCIP - O. Magana) FIELD_STRUCT_DESC: 30-inch steel drainage pipe through the levee, 11.1 feet below the crown. Corrugated metal cutoff wall around pipe at the center of the levee. Siphon breaker is located on both waterside (WS) and landside (LS). Pump is located on the LS approximately 300 feet from LS toe. Pipe is exposed on both levee slopes. Rock revetment present along WS slope. Marine Station number 1 located on WS with an attached small solar panel on top. [Additional Reference(s): DWR Levee Log, 1992. USACE Sacramento O&M Manual Unit No. 101, February 1962, (HLM 0.0). LMA encroachment station (STA) reference based on Map of Evacuation Route, Reclamation District 341 Sherman Island by Wagner Bonsignore Consulting Civil Engineers, A Corporation dated July 2012, STA 175+00]. FS Date: 5/5/2009

Overview of LS slope above ground once it exits levee. Pump is located approximately 300 feet from levee toe.

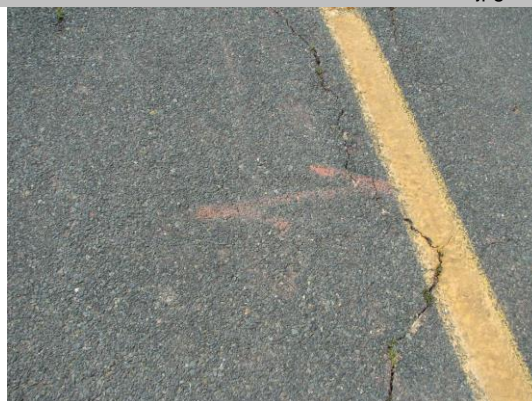
Photo 1 of 3 : UCIP_FA_2019_52253_37647.jpg

DS_ID:24110
FS_ID:52253
EP_NO: 6297
Repair Type: Non-Urgent
Crossing Status: Found
UCIP Comments: 07/06/2016 According to LMA Superintendent, Joel McElroy, the posts located on WS are markers indicating line. Line comes from Twitchel Island to Sherman Island. (DWR UCIP - O. Magana)
05/05/2009 Markers Missing. Underground alert service (USA) markings visible on road surface. No markers found to confirm crossing is still in use--need to contact owner to determine status of crossing. (DWR UCIP - O. Magana)
FIELD_STRUCT_DESC: 3-inch electrical transmission cable of unknown material through the levee, 3.5 feet below the crown. Location marker located on the waterside (WS) shoulder--no marker found in 2013. Pole located on the landside (LS). Rock revetment along the on WS slope. (Permit No. 6297, 1969 - Pacific Gas and Electric Company [PG&E]) [Additional Reference(s): DWR Levee Log, 1992. LMA encroachment station (STA) reference based on Map of Evacuation Route, Reclamation District 341 Sherman Island by Wagner Bonsignore Consulting Civil Engineers, A Corporation dated July 2012, STA 148+00]

Underground Service Alert (USA) markings on road surface indicating line is still present.

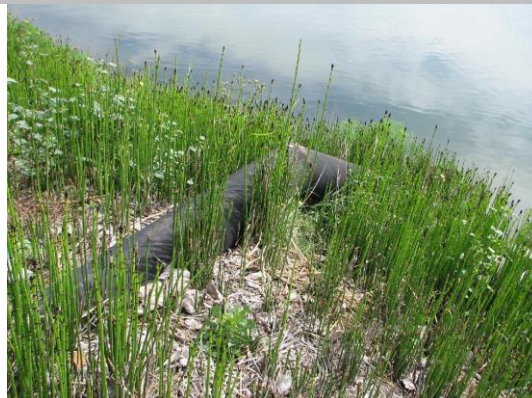
Photo 3 of 3 : UCIP_FA_2019_52254_37655.jpg

Comment Code						
Inspector Comment						
DS_ID:24111 FS_ID:52254 EP_NO: 1477 Repair Type: Non-Urgent Crossing Status: Found UCIP Comments: 07/06/2016 According to LMA Superintendent, Joel McElroy, the LS pipe section was replaced in about 2005 under the Three Mile Slough Project. No work was completed on crown or WS. (DWR UCIP - O. Magana) 05/05/2009 Dense vegetation limits the inspector's visibility to identify signs of pipe failure (leaks) along the slopes. Recommend removing vegetation along pipe alignment to conduct proper inspection of structure and appurtenances. (DWR UCIP - O. Magana) FIELD_STRUCT_DESC: 10-inch steel irrigation siphon pipe through the levee, 1.8 feet below the crown. 10-inch pipe is encased in 12-inch corrugated metal conduit under crown. Pump is located on landside (LS). Air vent and metal distribution box with gate are located on the LS. Rock revetment placed along the waterside (WS) slope. A 30-foot section of pipe under the crown was replaced and encased in corrugated metal pipe (CMP) under unknown permit. (10-inch pipe authorized under Permit No. 1477, 1950 - L. J. Anderson) [Additional Reference(s): DWR Levee Log, 1992. USACE Sacramento O&M Manual Unit No. 101, February 1962, (HLM 0.50). LMA encroachment station (STA) reference based on Map of Evacuation Route, Reclamation District 341 Sherman Island by Wagner Bonsignore Consulting Civil Engineers, A Corporation dated July 2012, STA 149+00] FS Date: 5/5/2009

View of pipe on WS.

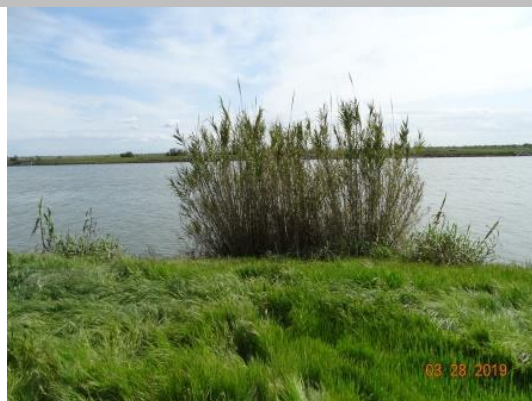
Photo 1 of 1 : FA_2019_RD0341_167_32_20190826_00008.jpg

LM Start	0.74	Rating **	M	Issue No.	32
LM End	0.74	Issue Type +	Ma	Location *	WS
Category	Earthen Levee			GPS Latitude/Longitude	
				Start	End
Item	Vegetation			38.096136 °	38.096136 °
				-121.686953 °	-121.686953 °
DWR ID	DWR_RD0341_01_s_2019_32				
Comment Code					
V2 : Remove the wild growth other than native grasses from the levee slopes.					
Inspector Comment					
Remove arundo from waterside slope.

View looking downslope at arundo on the waterside (Spring 2019).

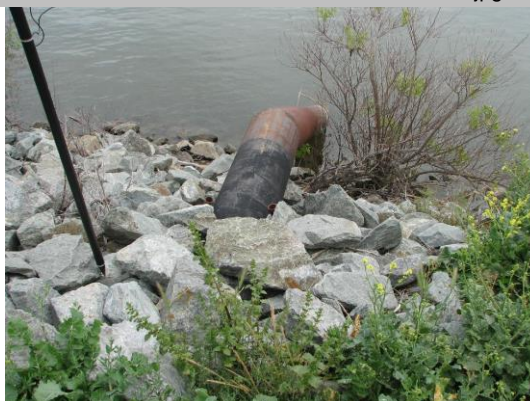
Photo 1 of 3 : UCIP_FA_2019_52255_37664.jpg

Comment Code						
Inspector Comment						
DS_ID:24113 FS_ID:52255 EP_NO: 11095 Repair Type: Non-Urgent Crossing Status: Found UCIP Comments: 07/06/2016 According to LMA Superintendent, Joel McElroy, this pipe is an irrigation siphon pipe and not a drainage pipe. Primer stem and primer is located on the LS near the berry shrubs. (DWR UCIP - O. Magana) 05/05/2009 Dense vegetation limits the inspector's visibility to identify signs of pipe failure (leaks) along the slope. Recommend removing vegetation along pipe alignment to conduct proper inspection of structure and appurtenances. (DWR UCIP - O. Magana) FIELD_STRUCT_DESC: 18-inch steel irrigation siphon pipe sleeved through 24-inch pipe through the levee, 4 feet below the crown. Primer stem and primer located on the landside (LS). Pipe exposed on the waterside (WS) slope. (18-inch pipe authorized under Automatic Board Order (ABO) issued as Permit No. 11095, 1975 - A. M. Cabral). [Additional Reference(s): DWR Levee Log, 1992. LMA encroachment station (STA) reference based on Map of Evacuation Route, Reclamation District 341 Sherman Island by Wagner Bonsignore Consulting Civil Engineers, A Corporation dated July 2012, STA 118+00] FS Date: 5/5/2009

View of pipe located on WS.

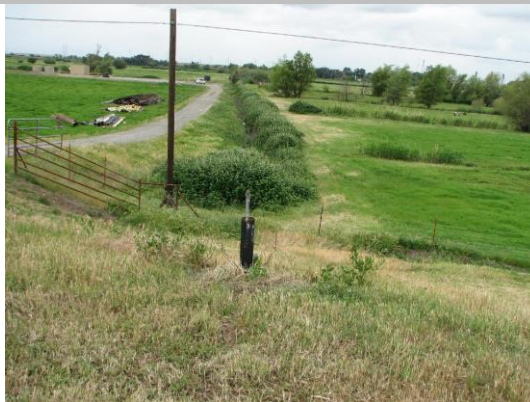
Photo 2 of 3 : UCIP_FA_2019_52255_37663.jpg

View of LS--visible standup pipe with primer stem is located on the LS slope.

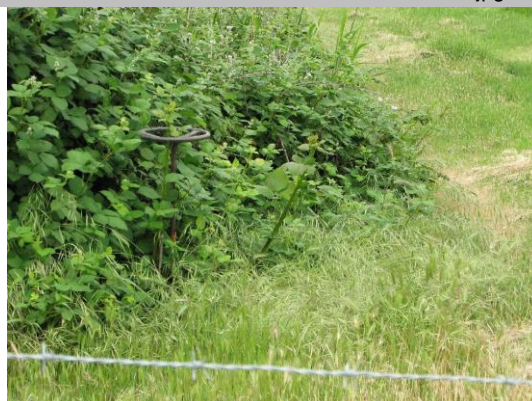
Photo 3 of 3 : UCIP_FA_2019_52255_37662.jpg

Comment Code						
Inspector Comment						
DS_ID:24113 FS_ID:52255 EP_NO: 11095 Repair Type: Non-Urgent Crossing Status: Found UCIP Comments: 07/06/2016 According to LMA Superintendent, Joel McElroy, this pipe is an irrigation siphon pipe and not a drainage pipe. Primer stem and primer is located on the LS near the berry shrubs. (DWR UCIP - O. Magana) 05/05/2009 Dense vegetation limits the inspector's visibility to identify signs of pipe failure (leaks) along the slope. Recommend removing vegetation along pipe alignment to conduct proper inspection of structure and appurtenances. (DWR UCIP - O. Magana) FIELD_STRUCT_DESC: 18-inch steel irrigation siphon pipe sleeved through 24-inch pipe through the levee, 4 feet below the crown. Primer stem and primer located on the landside (LS). Pipe exposed on the waterside (WS) slope. (18-inch pipe authorized under Automatic Board Order (ABO) issued as Permit No. 11095, 1975 - A. M. Cabral). [Additional Reference(s): DWR Levee Log, 1992. LMA encroachment station (STA) reference based on Map of Evacuation Route, Reclamation District 341 Sherman Island by Wagner Bonsignore Consulting Civil Engineers, A Corporation dated July 2012, STA 118+00] FS Date: 5/5/2009

Gate located past the fence area near LS toe.

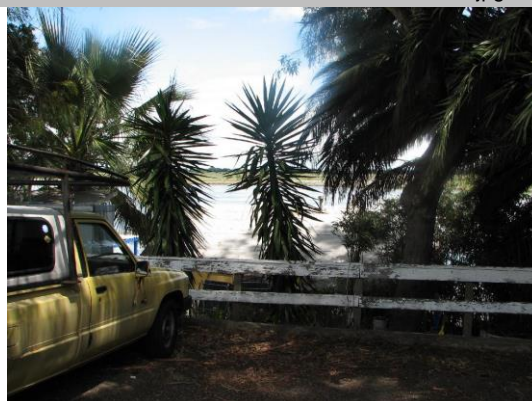
Photo 1 of 3 : UCIP_FA_2019_52258_37706.jpg

Comment Code						
Inspector Comment						
DS_ID:24116 FS_ID:52258 EP_NO: 11103 Repair Type: Non-Urgent Crossing Status: Found UCIP Comments: 05/05/2009 Unable to determine if crossing is the same as permitted under permit no. 11103. Need to contact owner and determine status of crossing under permit no. 11103. Believe steel conduit is exposed on landward side. (DWR UCIP - O. Magana) FIELD_STRUCT_DESC: 1.5-inch iron water pipe and 3.5-inch electrical steel conduit through the levee, both 3 feet below the crown. Pressure system and service pole located on the landside (LS) slope. Fishing resort located on the waterside (WS). (1.5-inch pipe authorized under Automatic Board Order (ABO) issued as Permit No. 11103, 1975 - Western Water Ways, Inc.; 3.5-inch not listed in Permit No. 11103) [Additional Reference(s): DWR Levee Log, 1992. LMA encroachment station (STA) reference based on Map of Evacuation Route, Reclamation District 341 Sherman Island by Wagner Bonsignore Consulting Civil Engineers, A Corporation dated July 2012, STA 71+00] FS Date: 5/5/2009

View of WS.

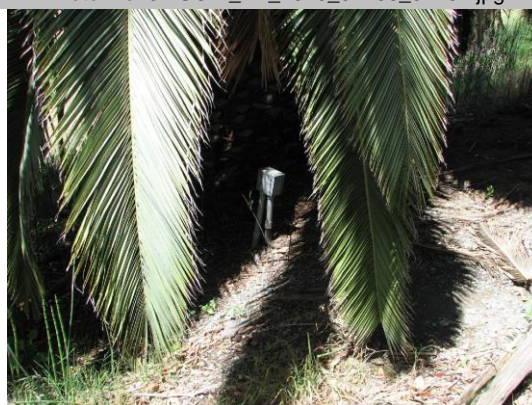
Photo 2 of 3 : UCIP_FA_2019_52258_37704.jpg

Power connection on WS no other appurtenances found.

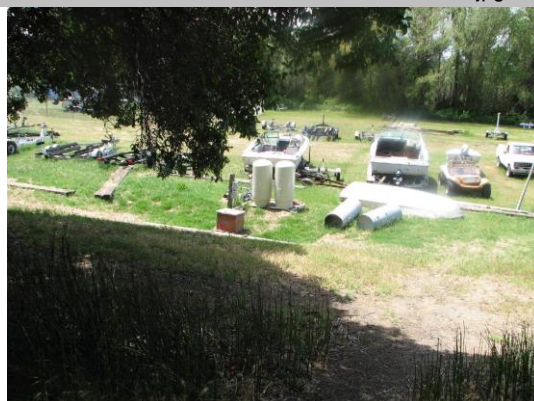
Photo 3 of 3 : UCIP_FA_2019_52258_37703.jpg

Comment Code						
Inspector Comment						
DS_ID:24116 FS_ID:52258 EP_NO: 11103 Repair Type: Non-Urgent Crossing Status: Found UCIP Comments: 05/05/2009 Unable to determine if crossing is the same as permitted under permit no. 11103. Need to contact owner and determine status of crossing under permit no. 11103. Believe steel conduit is exposed on landward side. (DWR UCIP - O. Magana) FIELD_STRUCT_DESC: 1.5-inch iron water pipe and 3.5-inch electrical steel conduit through the levee, both 3 feet below the crown. Pressure system and service pole located on the landside (LS) slope. Fishing resort located on the waterside (WS). (1.5-inch pipe authorized under Automatic Board Order (ABO) issued as Permit No. 11103, 1975 - Western Water Ways, Inc.; 3.5-inch not listed in Permit No. 11103) [Additional Reference(s): DWR Levee Log, 1992. LMA encroachment station (STA) reference based on Map of Evacuation Route, Reclamation District 341 Sherman Island by Wagner Bonsignore Consulting Civil Engineers, A Corporation dated July 2012, STA 71+00] FS Date: 5/5/2009

View of LS.

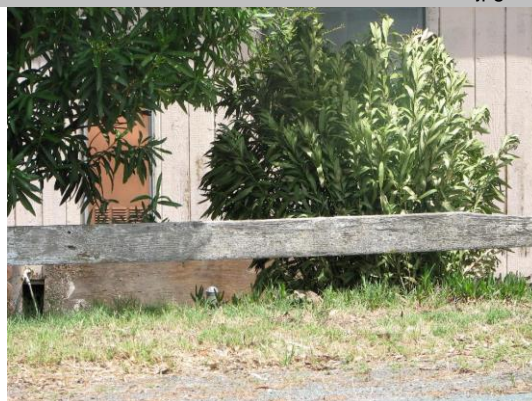
Photo 3 of 3 : UCIP_FA_2019_52259_37710.jpg

Comment Code						
Inspector Comment						
DS_ID:24117						
FS_ID:52259						
EP_NO: 5427						
Repair Type: Non-Urgent						
Crossing Status: Indicator Found						
UCIP Comments: 07/06/2016 According to LMA Superintendent, Joel McElroy, the features on the LS include sump pump inside well and drain leach field. The septic line pumps from WS to LS and deposit water in hole. (DWR UCIP - O. Magana)						
05/05/2009 Unable to find pipe or sump pump. Indicators found on landward side include potential septic tank and observation well. Need to contact owner of crossing to determine status of crossing. (DWR UCIP - O. Magana)						
FIELD_STRUCT_DESC: 1 of 2: 4-inch galvanized iron sewage pipe sleeved through 6-inch steel pipe through the levee, 3.7 feet below the crown. Sump pump located on the waterside (WS) slope. Septic tank and observation well are located on the landside (LS). (4-inch pipe authorized under Permit No. 5427, 1966 - Patrick's Resort) [Additional Reference(s): DWR Levee Log, 1992. LMA encroachment station (STA) reference based on Map of Evacuation Route, Reclamation District 341 Sherman Island by Wagner Bonsignore Consulting Civil Engineers, A Corporation dated July 2012, STA 69+00]

View of WS.

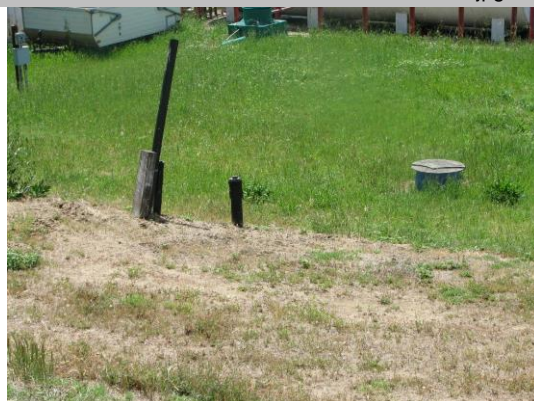
Photo 1 of 2 : UCIP_FA_2019_52260_37717.jpg

DS_ID:24237
FS_ID:52260
EP_NO: 5427
Repair Type: Non-Urgent
Crossing Status: Indicator Found
UCIP Comments: 05/05/2009 Signs of electrical connection boxes. Unable to determine if these boxes are associated to crossing. Need to contact owner to determine status of crossing. (DWR UCIP - O. Magana)
FIELD_STRUCT_DESC: 2 of 2: Five 1 to 1.5-inch pipes through the levee, 3.7 feet below the crown. Pump on waterward slope. Septic tank and observation well on the landward side. (conduit containing 1- to 1.5-inch pipes (per inspector's notes) authorized under Permit No. 5427, 1966 - Patrick's Resort) [Additional Reference(s): DWR Levee Log, 1992. LMA encroachment station (STA) reference based on Map of Evacuation Route, Reclamation District 341 Sherman Island by Wagner Bonsignore Consulting Civil Engineers, A Corporation dated July 2012, STA 68+00]
FS Date: 5/5/2009

Electrical conduit and box located on left corner of picture.

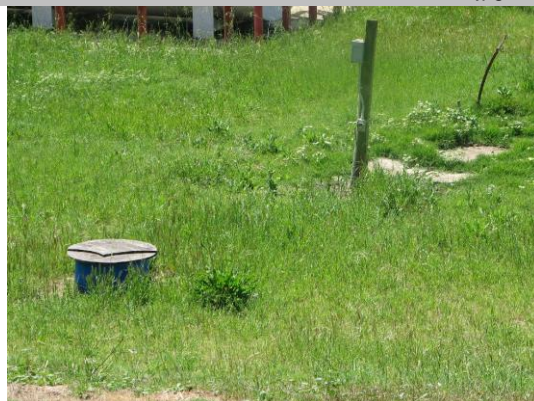
Photo 2 of 2 : UCIP_FA_2019_52260_37716.jpg

Electrical connection visible next to sump pump--right corner.

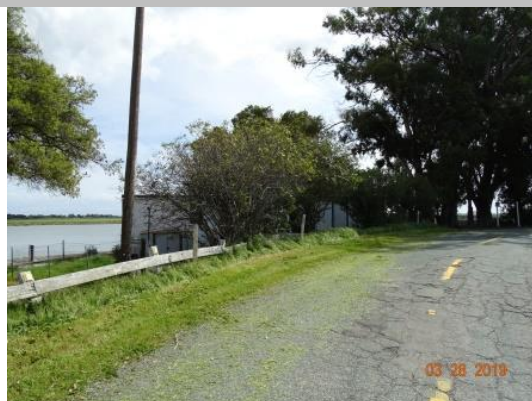
Photo 1 of 1 : FA_2019_RD0341_167_34_20190826_00010.jpg

LM Start	2.00	Rating **	M	Issue No.	34
LM End	2.00	Issue Type +	En	Location *	WS
Category	Earthen Levee			GPS Latitude/Longitude	
				Start	End
Item	Vegetation			38.114129 °	38.114129 °
				-121.684547 °	-121.684547 °
DWR ID	DWR_RD0341_01_s_2019_34				
Comment Code					
V6 : Landscaping					
Inspector Comment					
Remove landscaping on waterside.

View looking downstream at landscape on the waterside shoulder (Spring 2019).

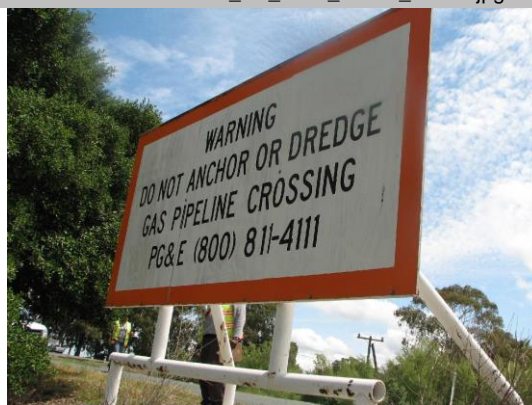
Photo 1 of 2 : UCIP_FA_2019_52261_37719.jpg

Comment Code						
Inspector Comment						
DS_ID:24119 FS_ID:52261 EP_NO: 960 Repair Type: Non-Urgent Crossing Status: Indicator Found UCIP Comments: 05/05/2009 Need to contact owner to determine last inspection and status of crossing. (DWR UCIP - O. Magana) FIELD_STRUCT_DESC: 1 of 2: 10-inch steel gas line through the levee, 2 feet below the levee crown. Cutoff wall around pipes located at the center of the levee. Valve pit located on the landside (LS) shoulder, with 2-inch drain pipe along LS slope. Location marker located on the waterside (WS) slope. Contact information for PG&E is 800-811-4111. (two 10-inch line authorized under Permit No. 960, 1944 - Pacific Gas and Electric Company [PG&E]; 10-inch pipes removed through levee-abandoned outside levee and replaced with unknown size pipes, and video inspection on gas line (G/L) 169, G/L 302, G/L 131 (p. 24 of 30), and G/L 141 authorized under Permit No. 15319, 1990 - PG&E; line referenced by PG&E as G/L 131) [Additional Reference(s): DWR Levee Log, 1992. USACE Sacramento O&M Manual Unit No. 101, February 1962 (HLM 2.04). LMA encroachment station (STA) reference based on Map of Evacuation Route, Reclamation District 341 Sherman Island by Wagner Bonsignore Consulting Civil Engineers, A Corporation dated July 2012, STA 67+00] FS Date: 5/5/2009

Pipeline marker located on WS shoulder.

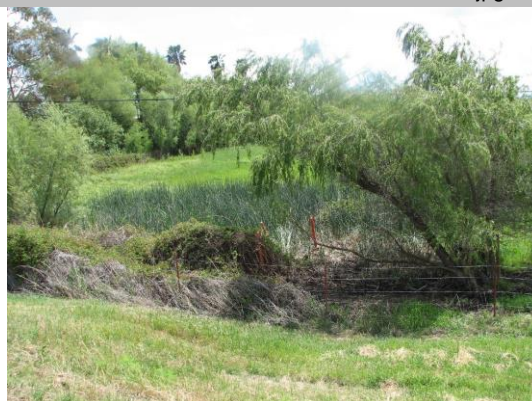
Photo 2 of 2 : UCIP_FA_2019_52261_37718.jpg

Comment Code						
Inspector Comment						
DS_ID:24119 FS_ID:52261 EP_NO: 960 Repair Type: Non-Urgent Crossing Status: Indicator Found UCIP Comments: 05/05/2009 Need to contact owner to determine last inspection and status of crossing. (DWR UCIP - O. Magana) FIELD_STRUCT_DESC: 1 of 2: 10-inch steel gas line through the levee, 2 feet below the levee crown. Cutoff wall around pipes located at the center of the levee. Valve pit located on the landside (LS) shoulder, with 2-inch drain pipe along LS slope. Location marker located on the waterside (WS) slope. Contact information for PG&E is 800-811-4111. (two 10-inch line authorized under Permit No. 960, 1944 - Pacific Gas and Electric Company [PG&E]; 10-inch pipes removed through levee-abandoned outside levee and replaced with unknown size pipes, and video inspection on gas line (G/L) 169, G/L 302, G/L 131 (p. 24 of 30), and G/L 141 authorized under Permit No. 15319, 1990 - PG&E; line referenced by PG&E as G/L 131) [Additional Reference(s): DWR Levee Log, 1992. USACE Sacramento O&M Manual Unit No. 101, February 1962 (HLM 2.04). LMA encroachment station (STA) reference based on Map of Evacuation Route, Reclamation District 341 Sherman Island by Wagner Bonsignore Consulting Civil Engineers, A Corporation dated July 2012, STA 67+00] FS Date: 5/5/2009

LS markers visible near levee toe.

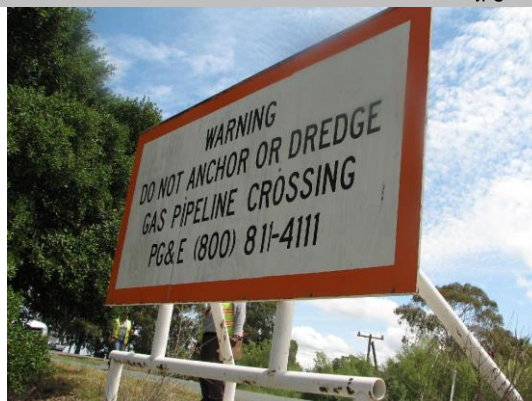
Photo 1 of 2 : UCIP_FA_2019_52262_37724.jpg

Comment Code						
Inspector Comment						
DS_ID:24242 FS_ID:52262 EP_NO: 960 Repair Type: Non-Urgent Crossing Status: Indicator Found UCIP Comments: 05/05/2009 Need to contact owner to determine last inspection and status of crossing. (DWR UCIP - O. Magana) FIELD_STRUCT_DESC: 2 of 2: 10-inch steel gas line through the levee, 2 feet below the levee crown. Cutoff wall around pipes located at the center of the levee. Valve pit located on the landside (LS) shoulder, with 2-inch drain pipe along LS slope. Location marker located on the waterside (WS) slope. Contact information for PG&E is 800-811-4111. (two 10-inch line authorized under Permit No. 960, 1944 - Pacific Gas and Electric Company [PG&E]; 10-inch pipes removed through levee-abandoned outside levee and replaced with unknown size pipes, and video inspection on gas line (G/L) 169, G/L 302, G/L 131 (p. 24 of 30), and G/L 141 authorized under Permit No. 15319, 1990 - PG&E; line referenced by PG&E as G/L 131) [Additional Reference(s): DWR Levee Log, 1992. USACE Sacramento O&M Manual Unit No. 101, February 1962 (HLM 2.04). LMA encroachment station (STA) reference based on Map of Evacuation Route, Reclamation District 341 Sherman Island by Wagner Bonsignore Consulting Civil Engineers, A Corporation dated July 2012, STA 67+00] FS Date: 5/5/2009

Warning marker visible on WS shoulder.

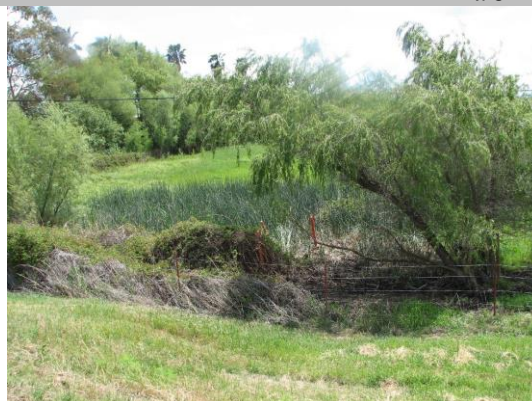
Photo 2 of 2 : UCIP_FA_2019_52262_37723.jpg

Markers also visible on LS near levee toe.

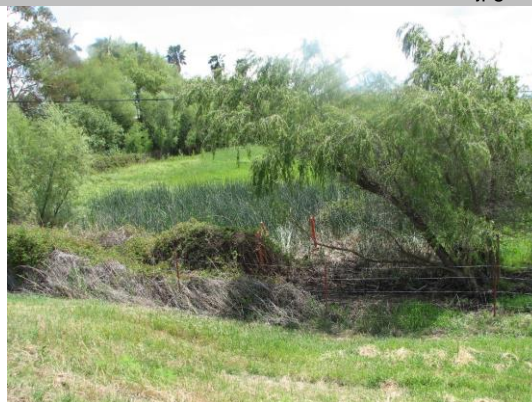
Photo 2 of 2 : UCIP_FA_2019_52263_71846.jpg

Comment Code						
Inspector Comment						
DS_ID:24756 FS_ID:52263 EP_NO: 17251 Repair Type: Non-Urgent Crossing Status: Indicator Found UCIP Comments: 03/04/2014 Need to contact owner to determine status of crossing. Need date of last inspection and confirmation that crossing is still in operable condition. (DWR UCIP - O. Magana) FIELD_STRUCT_DESC: 24-inch steel natural gas line through the levee, 125-feet below the levee crown (24-inch pipe authorized under Permit No. 17251 and 17251-Rev, 2002 - Lodi Gas Storage, LLC). [Additional Reference(s): LMA encroachment station (STA) reference based on Map of Evacuation Route, Reclamation District 341 Sherman Island by Wagner Bonsignore Consulting Civil Engineers, A Corporation dated July 2012, STA 64+00] FS Date: 3/4/2014

Markers visible on LS toe.

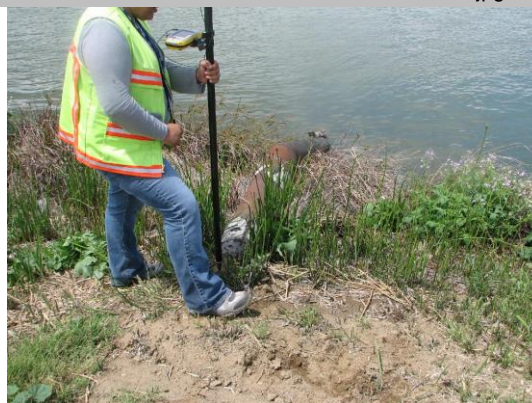
Photo 1 of 3 : UCIP_FA_2019_52264_37734.jpg

Comment Code						
Inspector Comment						
DS_ID:24120 FS_ID:52264 EP_NO: 11102 Repair Type: Non-Urgent Crossing Status: Found UCIP Comments: 07/06/2016 According to LMA Superintendent, Joel McElroy, the LS pipe was repaired/repaired under the Three Mile Slough Project in 2005, Setback Project, Project covers Station 10+00 to 175+00. (DWR UCIP - O. Magana) 05/05/2009 Dense vegetation limits the inspector's visibility to identify signs of pipe failure (leaks) along the slope. Recommend removing vegetation along pipe alignment to conduct proper inspection of structure and appurtenances. (DWR UCIP - O. Magana) FIELD_STRUCT_DESC: 10-inch steel irrigation pipe sleeved through a 12-inch pipe through the levee, 4.6 feet below the levee crown. Annular gap grouted between pipes. Irrigation canal with distribution box located on the landside (LS) toe. Rock revetment is located on the waterside (WS) slope. (10-inch pipe authorized under Automatic Board Order (ABO) issued as Permit No. 11102, 1975 - C. and E. Silva) [Additional Reference(s): DWR Levee Log, 1992. USACE Sacramento O&M Manual Unit No. 101, February 1962 (HLM 2.33). LMA encroachment station (STA) reference based on Map of Evacuation Route, Reclamation District 341 Sherman Island by Wagner Bonsignore Consulting Civil Engineers, A Corporation dated July 2012, STA 51+00] FS Date: 5/5/2009

View of pipe on WS.

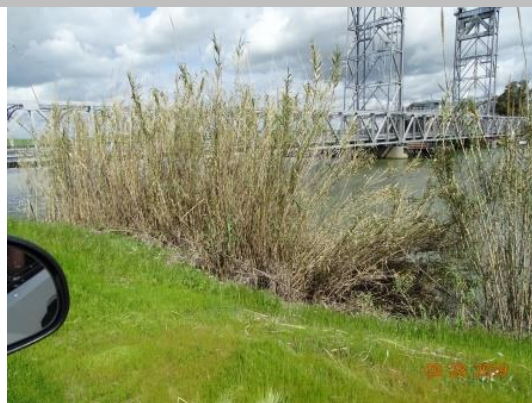
Photo 1 of 1 : FA_2019_RD0341_167_35_20190826_00011.jpg

LM Start	3.27	Rating **	M	Issue No.	35
LM End	3.27	Issue Type +	Ma	Location *	WS
Category	Earthen Levee			GPS Latitude/Longitude	
				Start	End
Item	Vegetation			38.105058 °	38.105058 °
				-121.701046 °	-121.701046 °
DWR ID	DWR_RD0341_01_s_2019_35				
Comment Code					
V2 : Remove the wild growth other than native grasses from the levee slopes.					
Inspector Comment					
Remove arundo from the waterside slope.

View looking upstream at arundo on the waterside slope (Spring 2019).

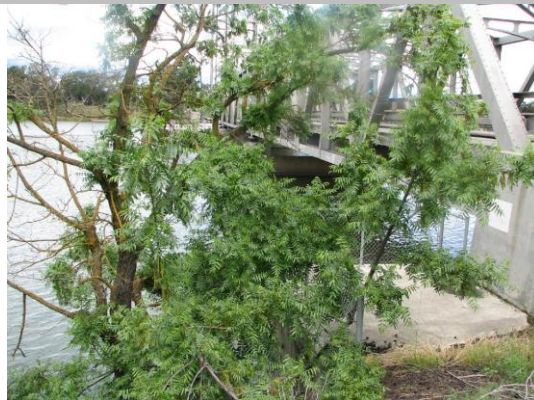
Photo 1 of 3 : UCIP_FA_2019_52267_37780.jpg

View of WS.

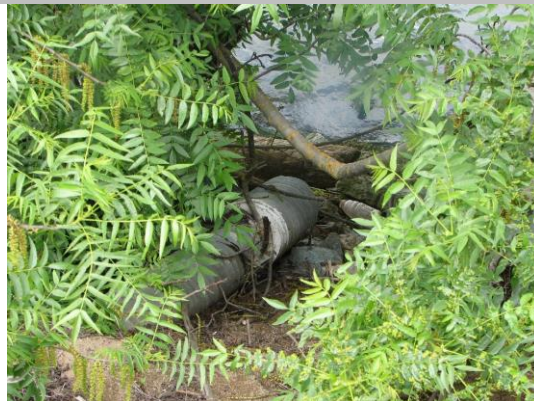
Photo 2 of 3 : UCIP_FA_2019_52267_37783.jpg

Pipe visible on the WS.

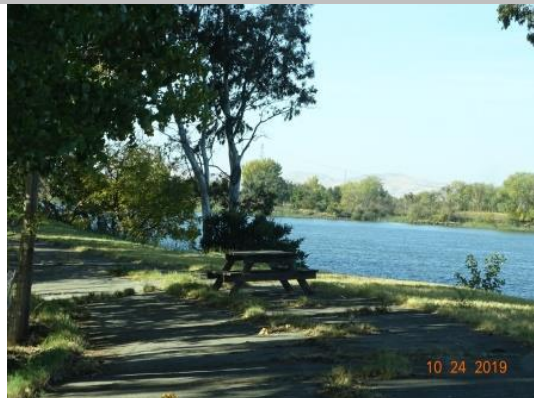
Photo 1 of 1 : FA_2019_RD0341_168_36_20191025_00088.jpg

LM Start	3.40	Rating **	M	Issue No.	36
LM End	3.40	Issue Type +	En	Location *	CR
Category	Earthen Levee			GPS Latitude/Longitude	
				Start	End
Item	Encroachments			38.105285 °	38.105285 °
				-121.703383 °	-121.703383 °
DWR ID	DWR_RD0341_02_f_2019_36				
Comment Code					
EQ : Equipment					
Inspector Comment

View of picnic table in the middle of the crown (Fall 2019).

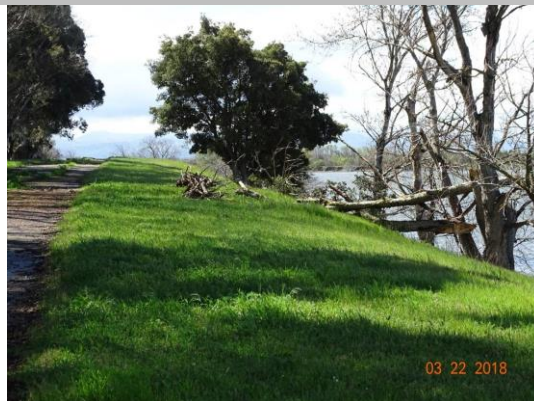
Photo 1 of 1 : FA_2019_RD0341_168_44_20190826_00013.jpg

LM Start	3.48	Rating **	M	Issue No.	44
LM End	3.48	Issue Type +	Ma	Location *	WS
Category	Earthen Levee			GPS Latitude/Longitude	
				Start	End
Item	Encroachments			38.104454 °	38.104454 °
				-121.704275 °	-121.704275 °
DWR ID	DWR_RD0341_02_s_2018_44				
Comment Code					
TR : Tree or limb					
Inspector Comment					
Remove tree limbs from waterside shoulder.

Tree limbs on waterside shoulder should be removed.

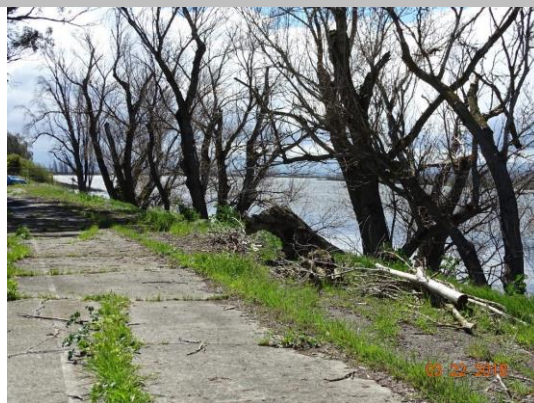
Photo 1 of 1 : FA_2019_RD0341_168_46_20190826_00014.jpg

LM Start	3.88	Rating **	M	Issue No.	46
LM End	3.93	Issue Type +	Ma	Location *	WS
Category	Earthen Levee			GPS Latitude/Longitude	
				Start	End
Item	Encroachments			38.099054 °	38.098327 °
				-121.706368 °	-121.706272 °
DWR ID	DWR_RD0341_02_s_2018_46				
Comment Code					
TR : Tree or limb					
Inspector Comment					
Remove tree and limbs from waterside shoulder.

Tree trunk and limbs should be removed from waterside shoulder.

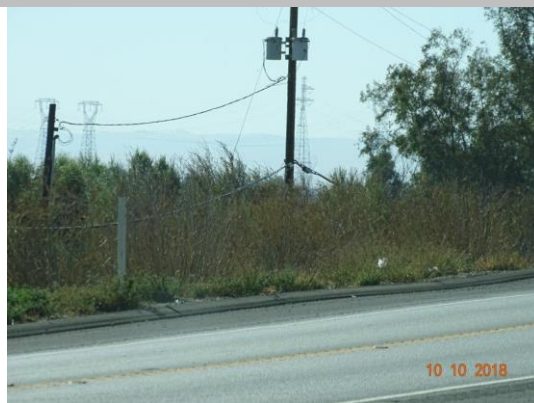
Photo 1 of 2 : FA_2019_RD0341_168_43_20190826_00011.jpg

LM Start	3.97	Rating **	M	Issue No.	43
LM End	6.03	Issue Type +	Ma	Location *	LS
Category	Earthen Levee			GPS Latitude/Longitude	
				Start	End
Item	Vegetation			38.097782 °	38.080143 °
				-121.706262 °	-121.728330 °
DWR ID	DWR_RD0341_02_f_2017_43				
Comment Code					
V2 : Remove the wild growth other than native grasses from the levee slopes.					
Inspector Comment

View of vegetation on the land side slope where the levee is on Highway 160 (October 2018).

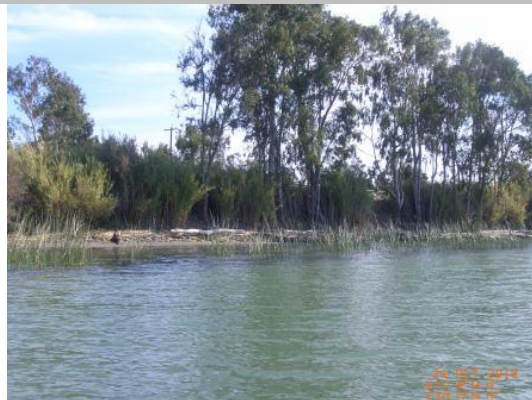
Photo 1 of 1 : FA_2019_RD0341_168_37_20190826_00004.jpg

LM Start	4.00	Rating **	M	Issue No.	37
LM End	4.19	Issue Type +	Ma	Location *	WS
Category	Supplemental			GPS Latitude/Longitude	
				Start	End
Item	2017 USACE Erosion Survey			38.097398 °	38.094590 °
				-121.706321 °	-121.706393 °
DWR ID	DWR_RD0341_02_f_2018_37				
Comment Code					
Inspector Comment					
2017 Site ID: SAC 8.2 L					
Status: Eroding					
2017 Field Notes: Minor new erosion.					
Site History: 2011 - Large new erosion pocket probably hidden by vegetation in the past.

USACE 2013 Photo #1

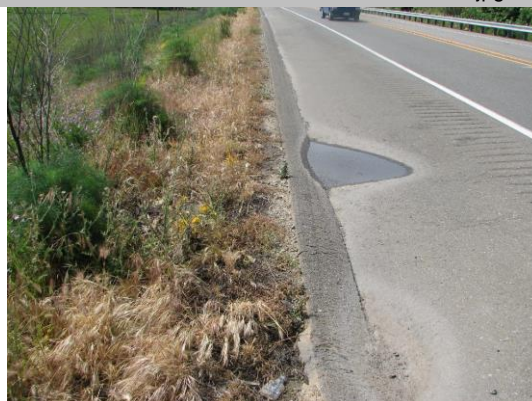
Photo 2 of 3 : UCIP_FA_2019_22203_37832.jpg

Comment Code						
Inspector Comment						
DS_ID:24135 FS_ID:22203 EP_NO: 11110 Repair Type: Non-Urgent Crossing Status: Found UCIP Comments: 07/06/2016 According to LMA Superintendent, Joel McElroy, DWR acquired land in 1995-2000 maybe earlier. Pipe is not used. Need to determine DWR Office is responsible for RD0341. Need to contact owner determine fate of crossing. (DWR UCIP - O. Magana) 05/06/2009 Need to determine status of crossing--need to contact owner. Dense vegetation limits the inspector's visibility to identify signs of pipe failure (leaks) along the slope. Recommend removing vegetation along pipe alignment to conduct proper inspection of structure and appurtenances. (DWR UCIP - O. Magana) FIELD_STRUCT_DESC: 10-inch steel irrigation pipe sleeved through 12-inch pipe through the levee, 3.8 feet below the crown. Pump on concrete well on landside (LS) slope. (10-inch pipe authorized under Automatic Board Order (ABO) issued as Permit No. 11110, 1975 - I. McKinnon, et al) [Additional Reference(s): DWR Levee Log, 1992. USACE Sacramento O&M Manual Unit No. 101, February 1962, (HLM 4.03). LMA encroachment station (STA) reference based on Map of Evacuation Route, Reclamation District 341 Sherman Island by Wagner Bonsignore Consulting Civil Engineers, A Corporation dated July 2012, STA 988+00] FS Date: 5/6/2009

View of landward shoulder and low spots on highway.

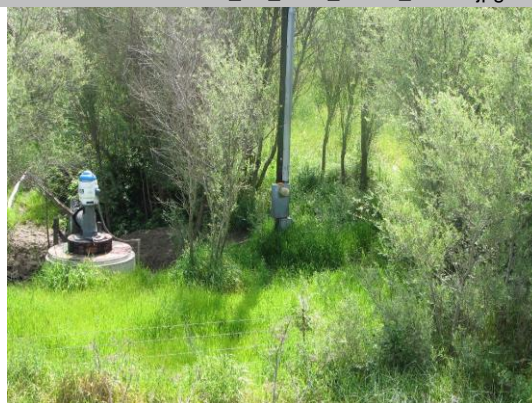
Photo 3 of 3 : UCIP_FA_2019_22203_37835.jpg

View of well and pump located on landward side.

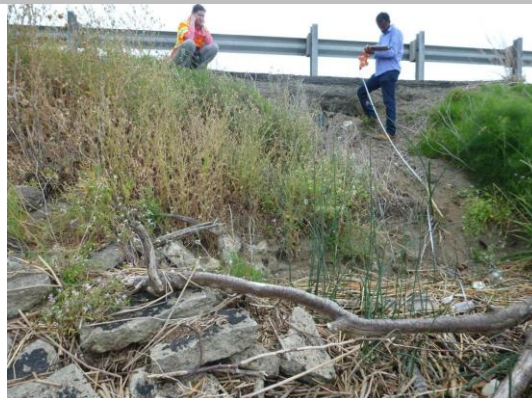
Photo 2 of 2 : FA_2019_RD0341_168_42_20190826_00010.jpg

LM Start	4.75	Rating **	A/W	Issue No.	42 (cont)	
LM End	4.79	Issue Type +	Ma	Location *		
Category	Supplemental			GPS Latitude/Longitude		
				Start		End
Item	2017 Storm Damage			38.086641 °		38.086119 °
				-121.707545 °		-121.707912 °
DWR ID	DWR_RD0341_02_s_2012_8					
Comment Code						
Inspector Comment						
Levee Evaluation Comments						
Description:						
Site ID No:65						
Site Designation:DWR_RD0341_02_s_2012_8						
Repair Type: Erosion						
Rating:Area of Concern						
Field Date:6/8/2017						
Notes: hwy 160 forms levee crown road, erosion has encroached into paved crown, crown 38' wide. This site is currently under contract for repair under FSRP.

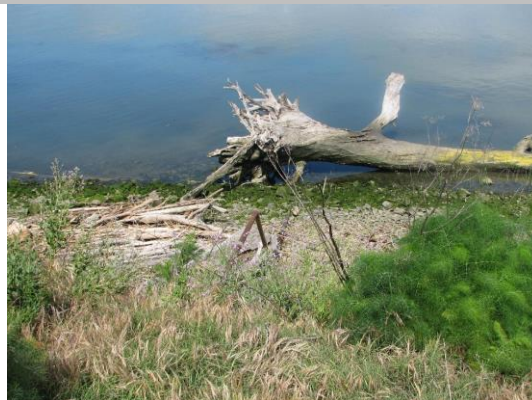
Photo 1 of 2 : UCIP_FA_2019_22186_37787.jpg

Comment Code					
Inspector Comment					
DS_ID:24123 FS_ID:22186 EP_NO: 4855 Repair Type: Non-Urgent Crossing Status: Found UCIP Comments: Dense vegetation limits the inspector's visibility to identify signs of pipe failure (leaks) along the slope. Recommend removing vegetation along pipe alignment to conduct proper inspection of structure and appurtenances. FIELD_STRUCT_DESC: 2-inch steel irrigation pipe through the levee, 3.0 feet below the crown. Valve and pump on landside (LS). Rock revetment placed on waterside (WS) slope. (2-inch pipe authorized under Permit No. 4855, 1965 - A. Cabral) [Additional Reference(s): DWR Levee Log, 1992. LMA encroachment station (STA) reference based on Map of Evacuation Route, Reclamation District 341 Sherman Island by Wagner Bonsignore Consulting Civil Engineers, A Corporation dated July 2012, STA 948+00] FS Date: 5/6/2009

View of crossing on waterward side--dense vegetation on slopes.

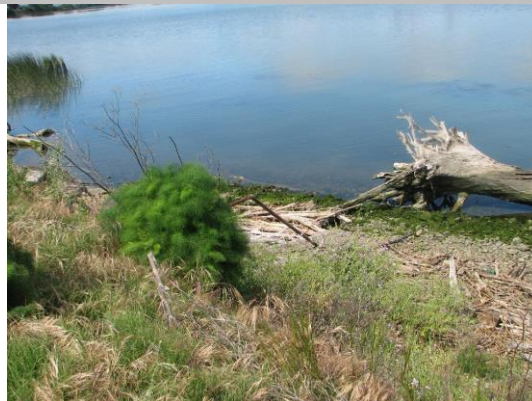
Photo 2 of 2 : UCIP_FA_2019_22186_37786.jpg

View of waterward toe.

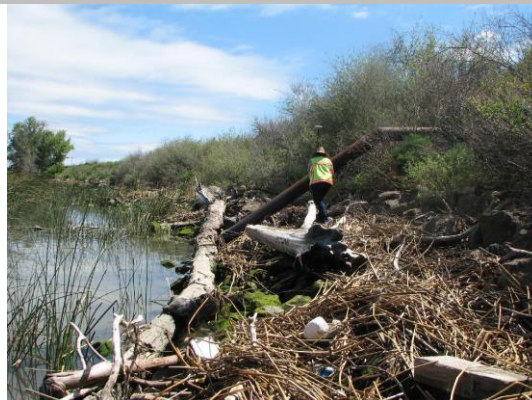
Photo 1 of 3 : UCIP_FA_2019_53343_37842.jpg

UCIP Comments: 9/5/2018 WS pipe end is severely corroded through and the LS pipe could not be found. Talked to LMA Rep and this pipe is no longer in use. Recommend internal inspection through levee due to pipe condition concern and so crossing remains Urgent (D. Sanoski - DWR UCIP). 7/6/2016 Meet with Joel McElroy, District Representative, at site. Difficult to access pipe from WS due to high traffic on levee crown and large debris scattered on WS toe. According to Joel McElroy, crossing is still present. Unable to access crossing from WS toe. Access should be made via boat. Assume crossing has gotten worse from last site visit. Need to find owner and coordinate with CVFPB to remove pipe. Mr. McElroy mentioned that Caltrans will be working on the Pavement Rehabilitation Project on State Route 160 and this crossing might be addressed by them. Project Manager for Pavement Rehabilitation Project is Kidianga Tshiunza, Caltrans District 3, 530-741-4178. (DWR UCIP - omagana) 5/6/2009 Crossing has failed. Large holes present on waterward side. Need to contact owner. Crossing needs to be addressed. Dense vegetation limits the inspector's visibility to identify signs of pipe failure (leaks) along the slope. Recommend removing vegetation along pipe alignment to conduct proper inspection of structure and appurtenances. (DWR UCIP - omagana)

FIELD_STRUCT_DESC: 12-inch steel irrigation pipe sleeved through 14-inch pipe through the levee, 6.8 feet below the crown. Hand primer pump in pump house on landside (LS) slope. Pipe exposed on both slopes (only visible on WS-2009). (14-inch pipe authorized under Permit No. 1806, 1959 - C. E. Upham, Jr.; no permit found authorizing the 12-inch sleeved pipe). [Additional Reference(s): DWR Levee Log, 1992. USACE Sacramento O&M Manual Unit No. 101, February 1962, (HLM 5.02). LMA encroachment station (STA) reference based on Map of Evacuation Route, Reclamation District 341 Sherman Island by Wagner Bonsignore Consulting Civil Engineers, A Corporation dated July 2012, STA 940+00].

View of crossing on waterward side. Dense vegetation limits inspection of crossing.

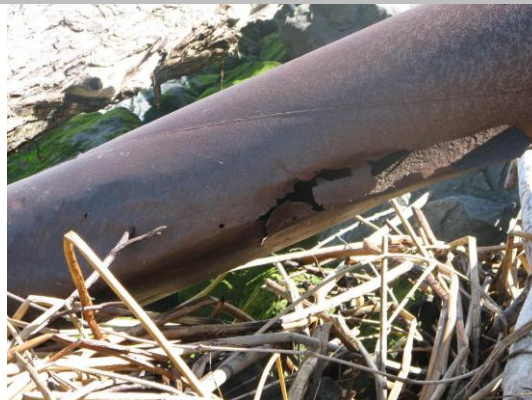
Photo 2 of 3 : UCIP_FA_2019_53343_37841.jpg

UCIP Comments: 9/5/2018 WS pipe end is severely corroded through and the LS pipe could not be found. Talked to LMA Rep and this pipe is no longer in use. Recommend internal inspection through levee due to pipe condition concern and so crossing remains Urgent (D. Sanoski - DWR UCIP). 7/6/2016 Meet with Joel McElroy, District Representative, at site. Difficult to access pipe from WS due to high traffic on levee crown and large debris scattered on WS toe. According to Joel McElroy, crossing is still present. Unable to access crossing from WS toe. Access should be made via boat. Assume crossing has gotten worse from last site visit. Need to find owner and coordinate with CVFPB to remove pipe. Mr. McElroy mentioned that Caltrans will be working on the Pavement Rehabilitation Project on State Route 160 and this crossing might be addressed by them. Project Manager for Pavement Rehabilitation Project is Kidianga Tshiunza, Caltrans District 3, 530-741-4178. (DWR UCIP - omagana) 5/6/2009 Crossing has failed. Large holes present on waterward side. Need to contact owner. Crossing needs to be addressed. Dense vegetation limits the inspector's visibility to identify signs of pipe failure (leaks) along the slope. Recommend removing vegetation along pipe alignment to conduct proper inspection of structure and appurtenances. (DWR UCIP - omagana)

Holes present on waterward side.

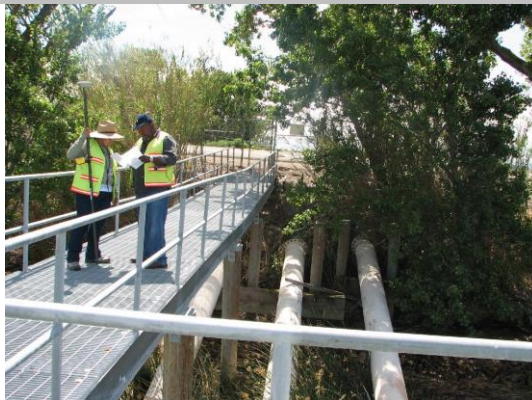
Photo 1 of 3 : UCIP_FA_2019_22253_37885.jpg

DS_ID:24195
FS_ID:22253
EP_NO: 15175
Repair Type: Non-Urgent
Crossing Status: Found
UCIP Comments: Dense vegetation limits the inspector's visibility to identify signs of pipe failure (leaks) along the slope. Recommend removing vegetation along pipe alignment to conduct proper inspection of structure and appurtenances.
FIELD_STRUCT_DESC: [Horseshoe Intake] 1 of 4: 24-inch steel irrigation pipe in 30-inch steel casings through the levee, 6.6 feet below the crown. Annular gap grouted between pipes. Siphon breakers located on the waterside (WS) shoulder, with concrete risers on both ends. Screened inlet manifold (36-inch) with backwash system on pile structure in stream. Surrounded by fence with entry gate. Irrigation pond located on the landside (LS) toe. (three 24-inch pipe authorized under Permit No. 15175, 1993 -Reclamation District 341 [RD0341]; replacement of 210 feet of existing 24-inch pipes, join two pipes at an inlet with a 36-inch screened manifold intake, add bypass valves on both lines, install an access platform, and pressurized backwash system to clean fish screens authorized under Permit No. 16737, 2000 - Department of Water Resources [DWR]) [Additional Reference(s): LMA encroachment station (STA) reference based on Map of Evacuation Route, Reclamation District 341 Sherman Island by Wagner Bonsignore Consulting Civil Engineers, A Corporation dated July 2012, STA 934+00]

Pipes, walkway, fence, and support piles located on waterward side.

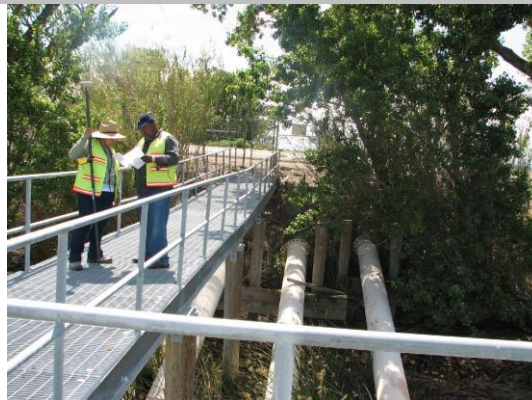
Photo 1 of 3 : UCIP_FA_2019_22254_37896.jpg

DS_ID:24239
FS_ID:22254
EP_NO: 15175
Repair Type: Non-Urgent
Crossing Status: Found
UCIP Comments: Dense vegetation limits the inspector's visibility to identify signs of pipe failure (leaks) along the slope. Recommend removing vegetation along pipe alignment to conduct proper inspection of structure and appurtenances.
FIELD_STRUCT_DESC: [Horseshoe Intake] 2 of 4: 24-inch steel irrigation pipe in 30-inch steel casings through the levee, 6.6 feet below the crown. Annular gap grouted between pipes. Siphon breakers located on the waterside (WS) shoulder, with concrete risers on both ends. Screened inlet manifold (36-inch) with backwash system on pile structure in stream. Surrounded by fence with entry gate. Irrigation pond is located on the landside (LS) toe. (three 24-inch pipe authorized under Permit No. 15175, 1993 -Reclamation District 341 [RD0341]; replacement of 210 feet of existing 24-inch pipes, join two pipes at an inlet with a 36-inch screened manifold intake, add bypass valves on both lines, install an access platform, and pressurized backwash system to clean fish screens authorized under Permit No. 16737, 2000 - Department of Water Resources [DWR]) [Additional Reference(s): LMA encroachment station (STA) reference based on Map of Evacuation Route, Reclamation District 341 Sherman Island by Wagner Bonsignore Consulting Civil Engineers, A Corporation dated July 2012, STA 934+00]

Pipes, walkway, fence, and support piles located on waterward side.

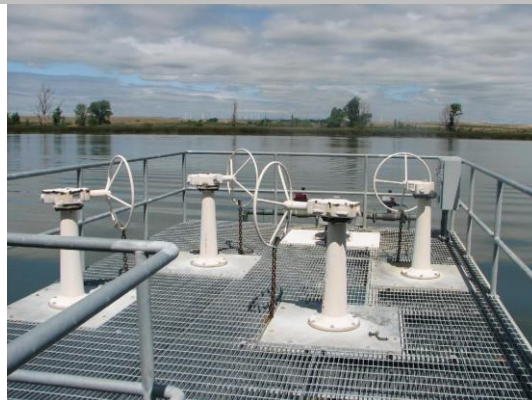
Photo 3 of 3 : UCIP_FA_2019_22255_37908.jpg

Item	DRAFT DWR UCIP Field Study		38.083133 °	38.083133 °								
			-121.710922 °	-121.710922 °								
DWR ID	24240											
Comment Code												
Inspector Comment												
DS_ID:24240 FS_ID:22255 EP_NO: 15175 Repair Type: Non-Urgent Crossing Status: Found UCIP Comments: Dense vegetation limits the inspector's visibility to identify signs of pipe failure (leaks) along the slope. Recommend removing vegetation along pipe alignment to conduct proper inspection of structure and appurtenances. FIELD_STRUCT_DESC: [Horseshoe Intake] 3 of 4: 24-inch steel irrigation pipe in 30-inch steel casings through the levee, 6.6 feet below the crown. Annular gap grouted. Siphon breakers at waterward shoulder, with concrete risers on both ends. Screened inlet manifold (36-inch) with backwash system on pile structure in stream. Surrounded by fence with entry gate. Irrigation pond at landward toe. (three 24-inch pipe authorized under Permit No. 15175, 1993 -Reclamation District 341 [RD0341]; replacement of 210 feet of existing 24-inch pipes, join two pipes at an inlet with a 36-inch screened manifold intake, add bypass valves on both lines, install an access platform, and pressurized backwash system to clean fish screens authorized under Permit No. 16737, 2000 - Department of Water Resources [DWR]) [Additional Reference(s): LMA encroachment station (STA) reference based on Map of Evacuation Route, Reclamation District 341 Sherman Island by Wagner Bonsignore Consulting Civil Engineers, A Corporation dated July 2012, STA 934+00] FS Date: 5/6/2009

Gates located on waterward side.

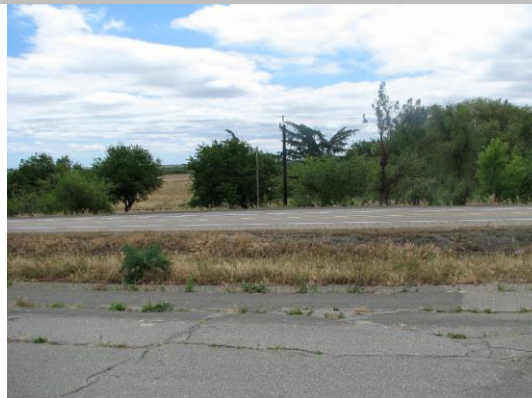
Photo 1 of 3 : UCIP_FA_2019_22256_37915.jpg

Overview of levee crown at crossing.

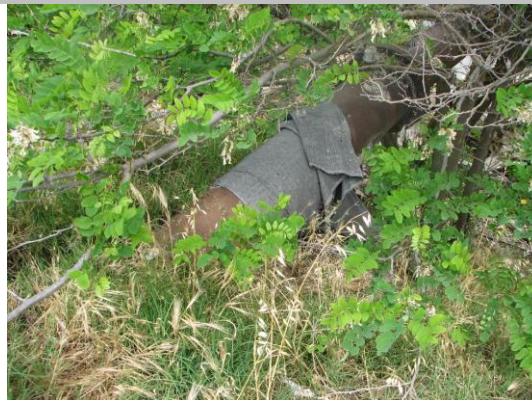
Photo 3 of 3 : UCIP_FA_2019_22256_37917.jpg

Comment Code						
Inspector Comment						
DS_ID:24127 FS_ID:22256 EP_NO: 11116 Repair Type: Non-Urgent Crossing Status: Found UCIP Comments: Need to coordinate with owner to determine status of crossing. If crossing is no longer in use owner will need to contact the CVFPB to comply with Title 23. Dense vegetation limits the inspector's visibility to identify signs of pipe failure (leaks) along the slope. Recommend removing vegetation along pipe alignment to conduct proper inspection of structure and appurtenances. FIELD_STRUCT_DESC: 16-inch steel irrigation pipe sleeved through 18-inch pipe through the levee, 2.5 feet below the crown. Annular gap grouted. Air vent on waterside (WS). (16-inch sleeved though 18-inch pipe authorized under Automatic Board Order (ABO) issued as Permit No. 11116, 1975 - C. E. & J. E. Upham; widen and realign State HWY 160 and extend three irrigation pipes authorized under Permit No. 15372, 1993 - Department of Transportation [Caltrans]) [Additional Reference(s): DWR Levee Log, 1992. USACE Sacramento O&M Manual Unit No. 101, February 1962, (HLM 5.40). LMA encroachment station (STA) reference based on Map of Evacuation Route, Reclamation District 341 Sherman Island by Wagner Bonsignore Consulting Civil Engineers, A Corporation dated July 2012, STA 917+00] FS Date: 5/6/2009

Pipe on waterward side at daylight.

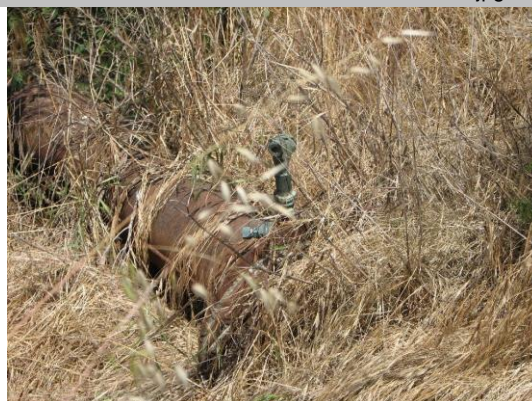
Photo 2 of 3 : UCIP_FA_2019_22258_37930.jpg

Air vent located on waterward side.

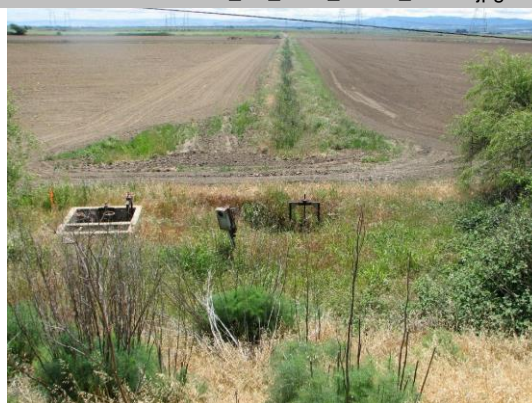
Photo 3 of 3 : UCIP_FA_2019_22258_37931.jpg

View of landward side.

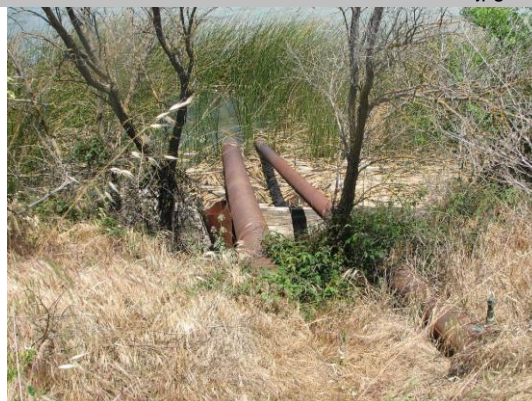
Photo 1 of 3 : UCIP_FA_2019_22259_37935.jpg

View of pipes on waterward side.

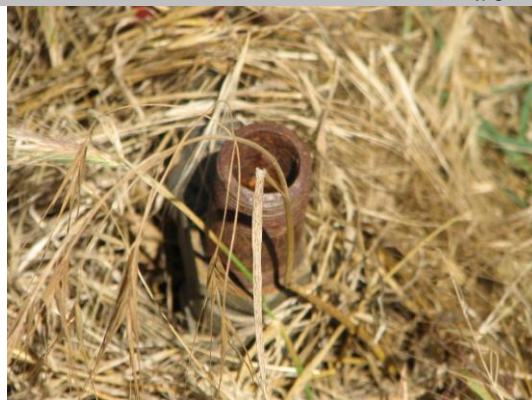
Photo 2 of 3 : UCIP_FA_2019_22259_37936.jpg

Primer stem located on waterward side.

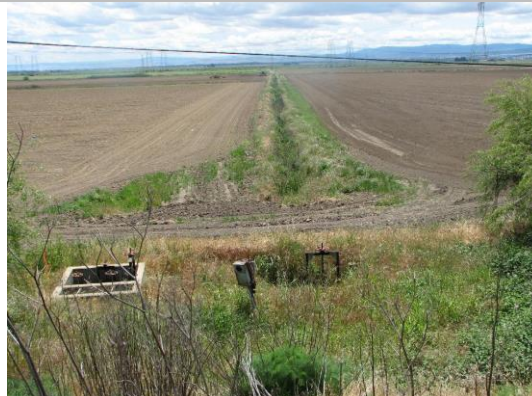
Photo 3 of 3 : UCIP_FA_2019_22259_37934.jpg

Comment Code						
Inspector Comment						
DS_ID:24075 FS_ID:22259 EP_NO: 1806 Repair Type: Non-Urgent Crossing Status: Found UCIP Comments: Dense vegetation limits the inspector's visibility to identify signs of pipe failure (leaks) along the slope. Recommend removing vegetation along pipe alignment to conduct proper inspection of structure and appurtenances. FIELD_STRUCT_DESC: 2 of 2: 14-inch steel irrigation pipe through the levee, 3 feet below the crown. Concrete distribution box with gate valve located on the landside (LS) toe. Air vent located on the waterside (WS). (14-inch pipe authorized under Permit No. 1806, 1959 - C. E. Upham, Jr.; distribution box installed and pipe along LS slope removed and replaced with longer 16-inch steel pipe authorized under Permit No. 15372, 1993 - Department of Transportation [Caltrans]) [Additional Reference(s): DWR Levee Log, 1992. USACE Sacramento O&M Manual Unit No. 101, February 1962, (HLM 5.81). LMA encroachment station (STA) reference based on Map of Evacuation Route, Reclamation District 341 Sherman Island by Wagner Bonsignore Consulting Civil Engineers, A Corporation dated July 2012, STA 891+00] FS Date: 5/6/2009

Gate located at the toe of the levee on landward side.

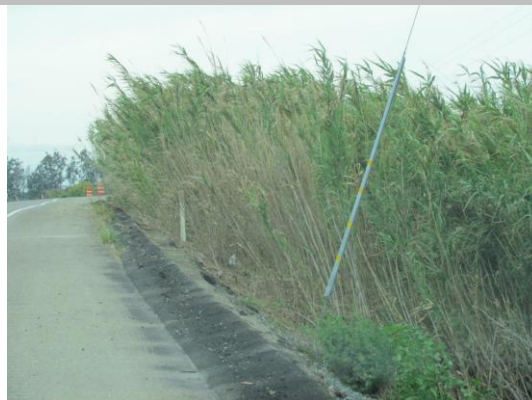
Photo 1 of 1 : FA_2019_RD0341_168_49_20190826_00016.jpg

LM Start	6.03	Rating **	U	Issue No.	49
LM End	6.10	Issue Type +	Ma	Location *	LS
Category	Earthen Levee			GPS Latitude/Longitude	
				Start	End
Item	Vegetation			38.080143 °	38.080125 °
				-121.728332 °	-121.729662 °
DWR ID	DWR_RD0341_02_f_2016_49				
Comment Code					
V2 : Remove the wild growth other than native grasses from the levee slopes.					
Inspector Comment					
Remove the arundo from the landside slope

RD 341 Landside slope from levee mile 6.03-6.10 tall unwanted growth of Arundo present on the levee section.

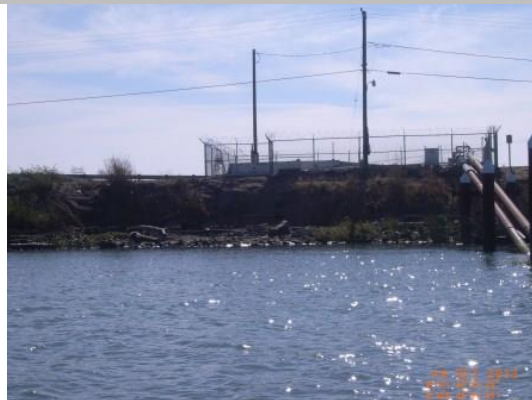
Photo 1 of 1 : FA_2019_RD0341_168_32_20190826_00001.jpg

LM Start	6.03	Rating **	U	Issue No.	32
LM End	6.16	Issue Type +	Ma	Location *	WS
Category	Supplemental			GPS Latitude/Longitude	
				Start	End
Item	2017 USACE Erosion Survey			38.080370 °	38.080526 °
				-121.728341 °	-121.730483 °
DWR ID	DWR_RD0341_02_f_2018_32				
Comment Code					
Inspector Comment					
2017 Site ID: SAC 7.3 L					
Status: Critical					
2017 Field Notes: No observed change..					
Site History: 2011 - Large slump at downstream end. Gully formed from surface runoff from the road. Shallow slumping throughout site.					
2012 - The gully at upstream end has increased in size and site continues to worsen.

USACE 2013 Photo #1

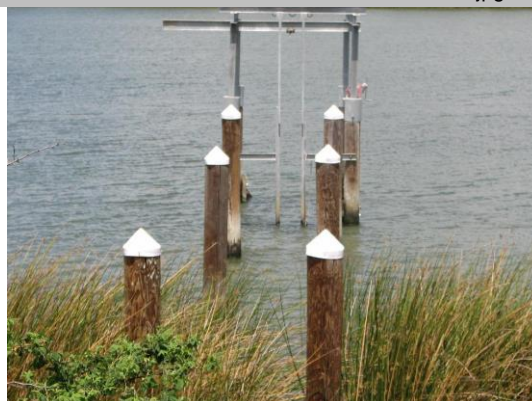
Photo 1 of 3 : UCIP_FA_2019_39861_71853.jpg

View of structure located on waterward side.

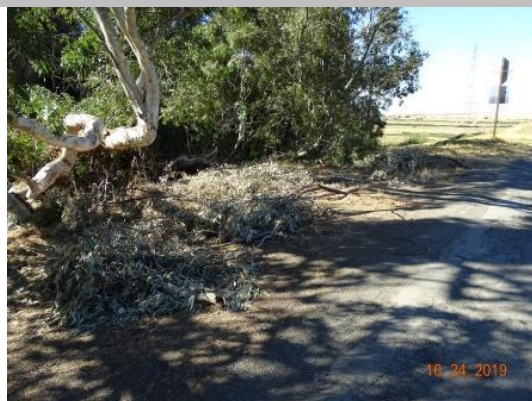
Photo 1 of 1 : FA_2019_RD0341_168_72_20191025_00092.jpg

LM Start	6.31	Rating **	M	Issue No.	72
LM End	6.31	Issue Type +	Ma	Location *	LS
Category	Earthen Levee			GPS Latitude/Longitude	
				Start	End
Item	Encroachments			38.081055 °	38.081055 °
				-121.733225 °	-121.733225 °
DWR ID	DWR_RD0341_02_f _ 2019_72				
Comment Code					
TR : Tree or limb					
Inspector Comment					
Remove prunings from LS shoulder.

Pruning piles on LS shoulder.

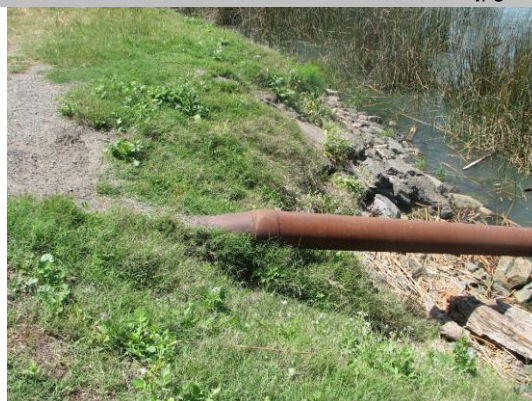
Photo 1 of 3 : UCIP_FA_2019_22261_37949.jpg

Side view of pipe on waterward side.

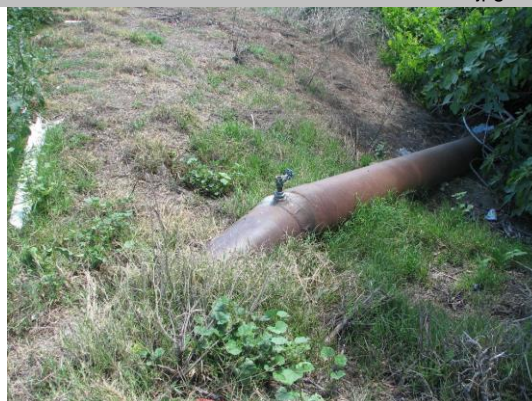
Photo 3 of 3 : UCIP_FA_2019_22261_37948.jpg

Comment Code						
Inspector Comment						
DS_ID:24078 FS_ID:22261 EP_NO: 11116 Repair Type: Non-Urgent Crossing Status: Found UCIP Comments: Dense vegetation limits the inspector's visibility to identify signs of pipe failure (leaks) along the slope. Recommend removing vegetation along pipe alignment to conduct proper inspection of structure and appurtenances. FIELD_STRUCT_DESC: 12-inch steel pipe of unknown purpose through the levee, 2 feet below the crown. Siphon breaker on landside (LS) slope. Rock revetment on waterside (WS) slope. (12-inch authorized under Automatic Board Order (ABO) issued as Permit No. 11116, 1975 - C. E. & J. E. Upham) [Additional Reference(s): DWR Levee Log, 1992. USACE Sacramento O&M Manual Unit No. 101, February 1962, (HLM 6.30). LMA encroachment station (STA) reference based on Map of Evacuation Route, Reclamation District 341 Sherman Island by Wagner Bonsignore Consulting Civil Engineers, A Corporation dated July 2012, STA 857+00] FS Date: 5/6/2009

View of crossing on landward slope.
